U.S. PUBLIC LAND SURVEY MONUMENT RECORD

T. 03 N. R. 11 E. 4th P.M.

CENTER TWP
ROCK COUNTY WI

CORNER CODE 543CE

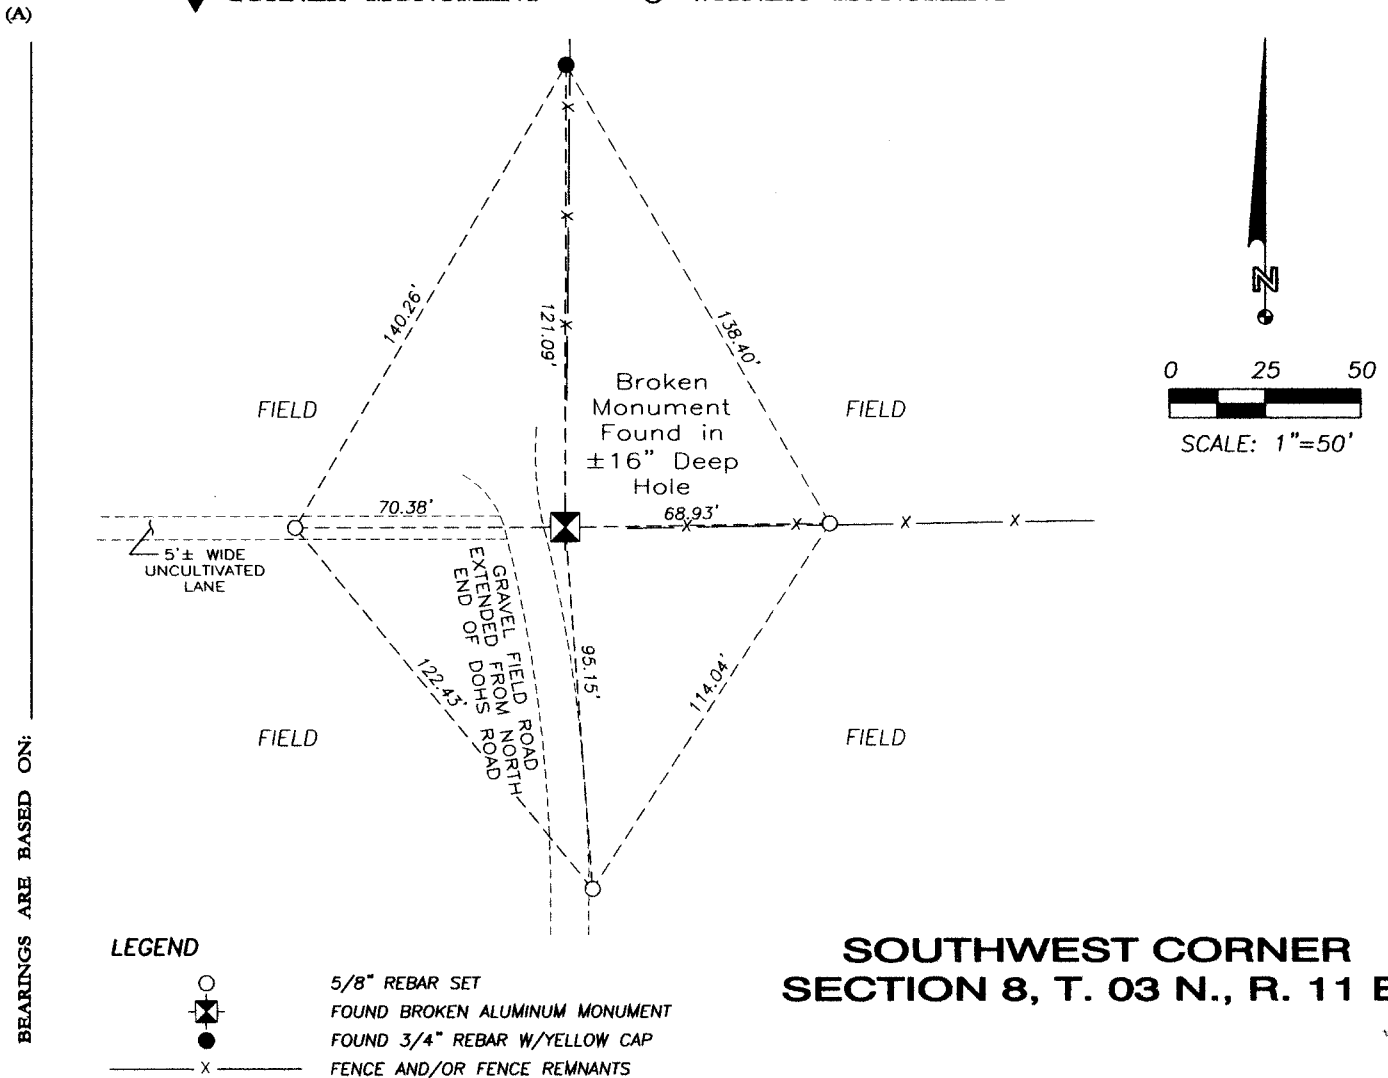
SHOW A PLAN VIEW DRAWING DEPICTING THE CORNER MONUMENT AND SURROUNDING PHYSICAL FEATURES, INCLUDING THE EXCAVATION AREA AND DEPTH.

I found a broken aluminum monument in a ±16 inch deep hole at the approximate intersection of fence and fence remnants running North and East and a 3/4" rebar w/yellow cap Witness Monument. The location fit coordinates provided by the Rock County Surveyor and the field located distance to the South 1/4 corner of Section 8, T 03 N, R 11 E agreed with the computed coordinate distance on file in the Rock County Surveyor's office.

I accepted the monument location and set 3 additional witness monuments as shown.
